Manhole Inspection Summary

Manhole # S04GG2017MH

Insp Date: **9/25/06 9:15 AM**

Location Address: **7007 BOXFORD RD**

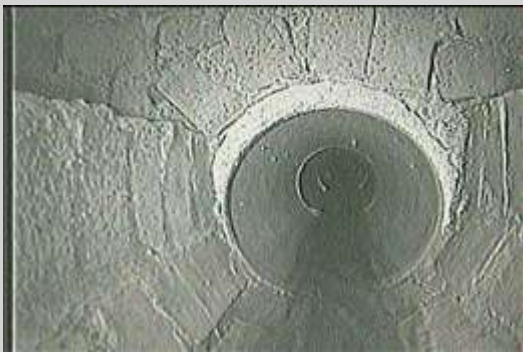
8 in. Circular Gravity Sewer Pipe Out @ 12 O'Clock

Rod and Bar (Angled)

Infiltration: **None** Pipe Seal Cond: **Unknown**
